LYSCOMBE CHAPEL & PRIEST'S HOUSE

LYSCOMBE FARM, PIDDLTRENTHIDE, DORCHESTER, DORSET

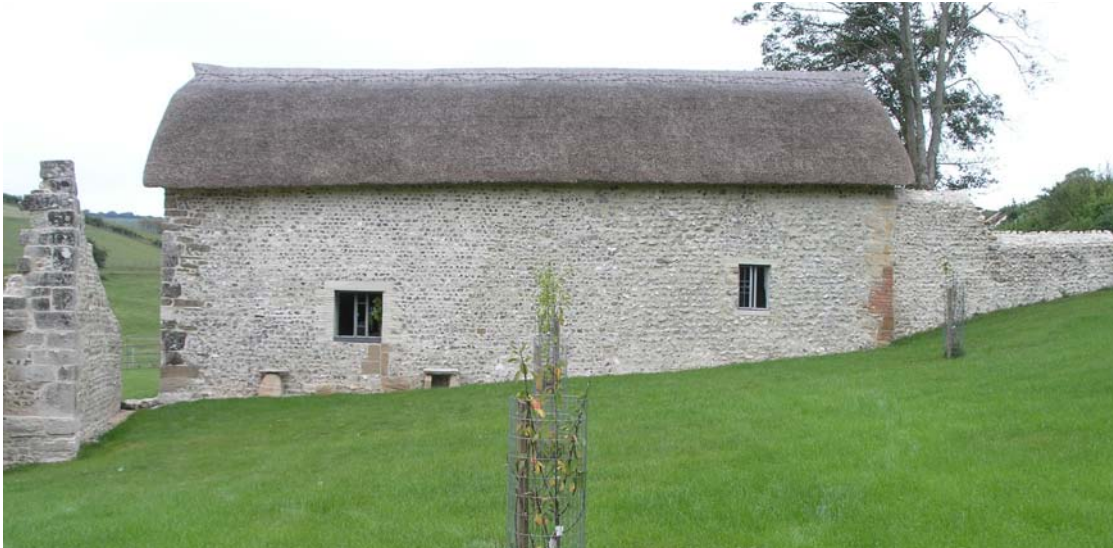
- 1 Chapel
- 2 Chapel interior
- 3 Mill pond & chapel
- 4 Chapel & Priest's House ruins
- 5 Repaired Priest's House
- 6 Chapel & repaired walls
- 7 New roof to Chapel
- 8 Chancel arch before repair
- 9 Window repair
- 10 Window detail

The chapel has been simply repaired with the traditional trades of lime mortar, masonry, green oak carpentry and thatched roofing.
